Pacific Gas and Electric Company
Natural Gas Transmission Pipeline Rupture and Fire
San Bruno, California
September 9, 2010

NTSB/PAR-11/01
PB2011-916501

Pipeline Accident Report

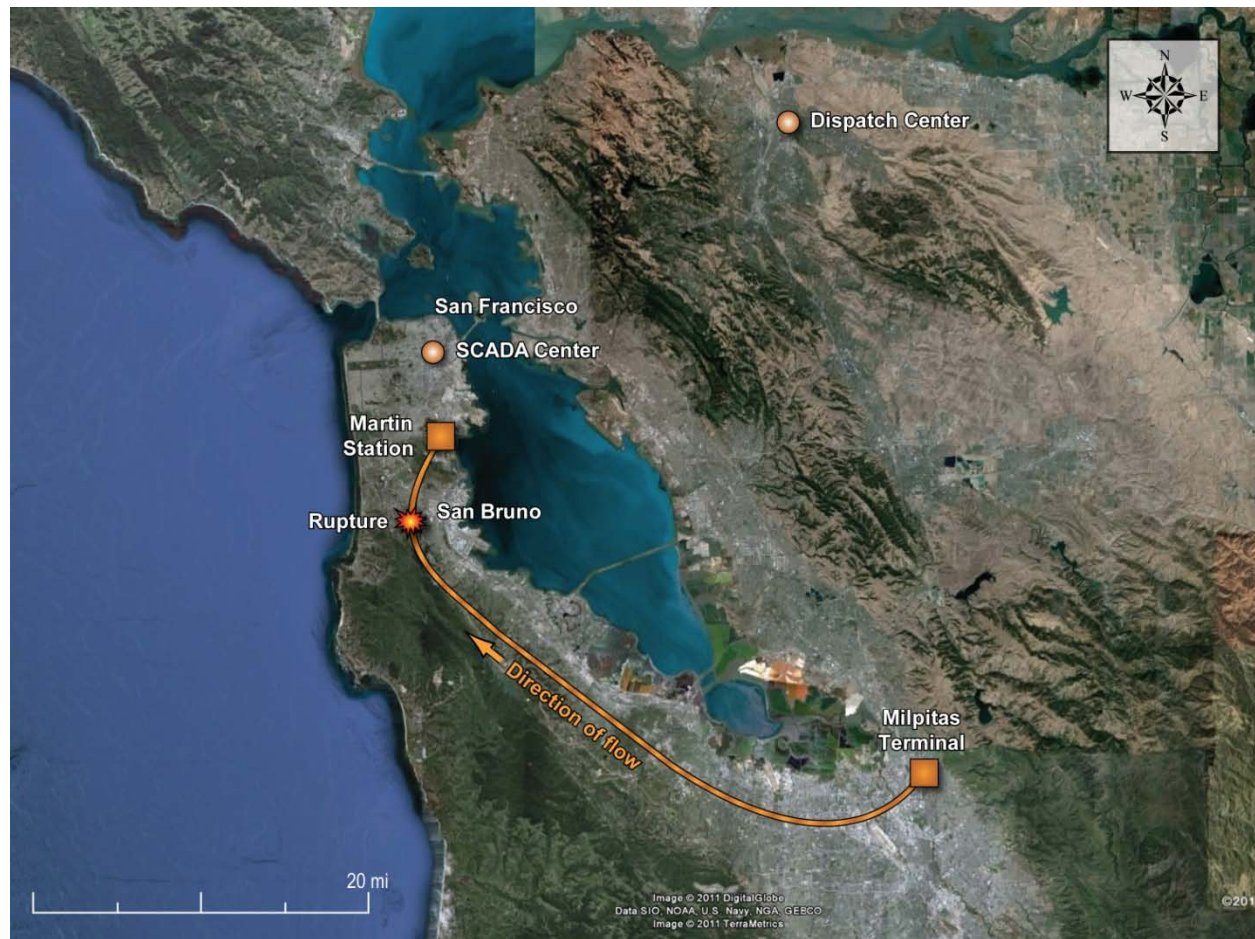
Figure 4. Overview of Line 132.

During the hours leading up to the accident, three PG&E employees and one contractor were working on an electrical distribution system as part of the replacement of the uninterruptible power supply (UPS)⁸ at the Milpitas Terminal, where Line 132 originates. (See figure 4.) The electric work had been approved by a PG&E work clearance⁹ form, which was submitted to PG&E's gas control center (referred to in this report as the SCADA¹⁰ center) on August 19, 2010, and approved on August 27, 2010.
